Final Report:

APPA Custodial Effectiveness Assessment
1537 Webster St. Oakland Ca, 94612

17 Sep 2013

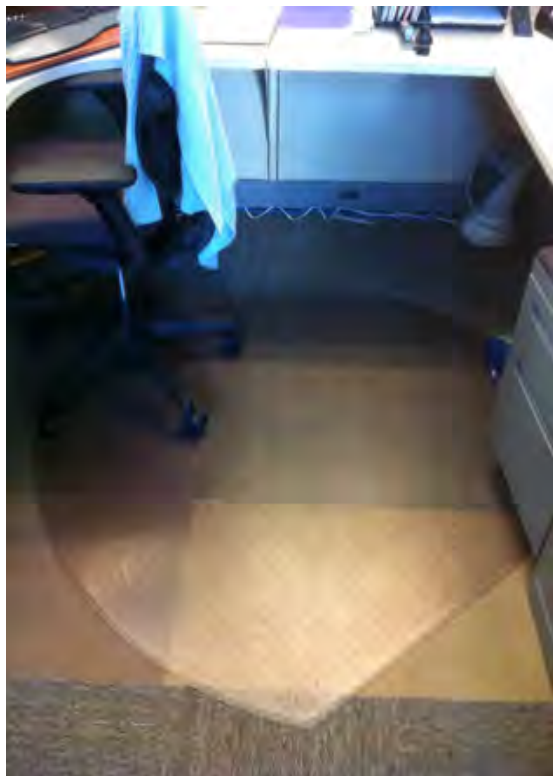
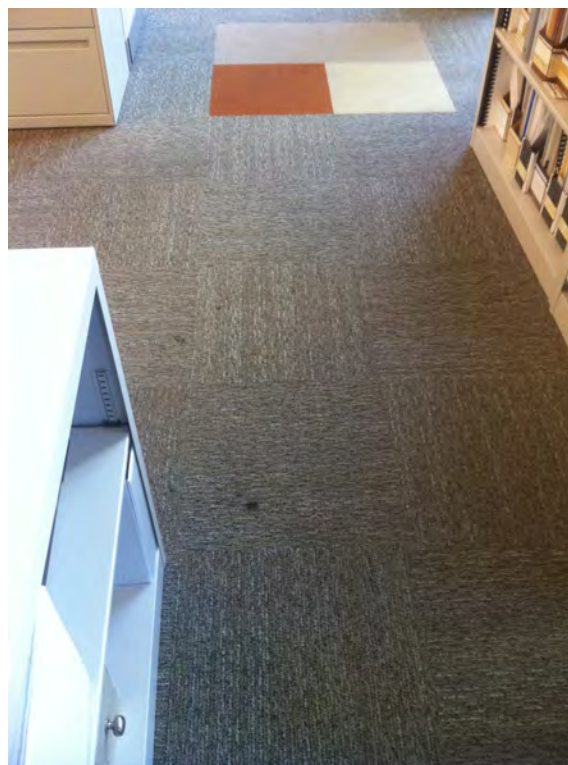
5. The flooring around desks were fairly well kept, no apparent evidence of markings indicative of caster abrasions due to the protective mats installed

Figure 1 - Example of flooring around cubicles

- b. Chair glides or pads for chair and couch feet that rest on resilient flooring is strongly recommended.
3. To elongate the life and quality of the carpet pile around desks, implement "desk chair mats" similar to a Realspace® 35% Recycled All-Pile Studded Chair Mat, 36" x 48" (Office Depot Item # 448906). These were found in some spaces.

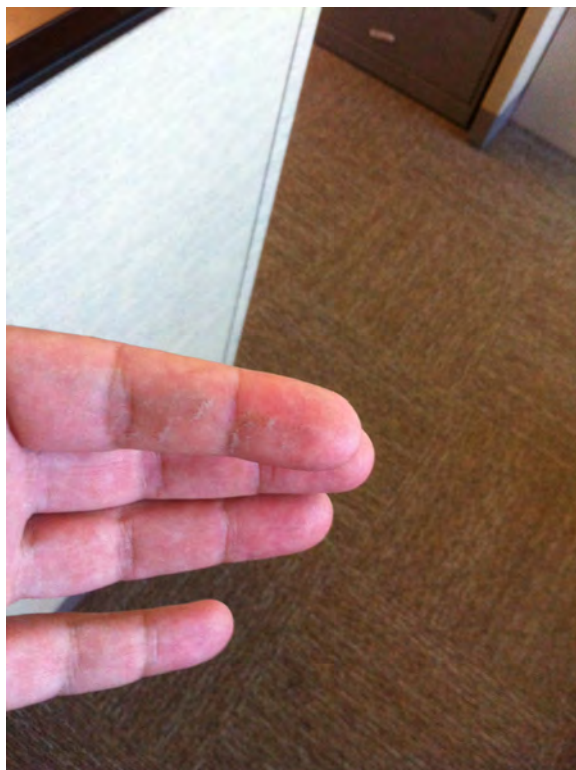
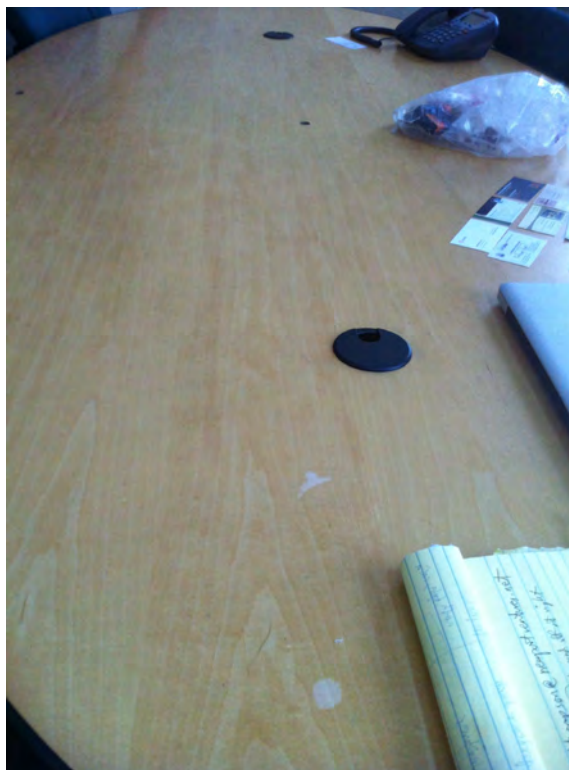
11. Dust was detected on:
 - a. Some horizontal surfaces (i.e. switch plate covers, top of doors)
 - b. Furnishings (i.e. file cabinets, cubicles)
12. Bathrooms were found to be neat and clean with the exception of the grout in the tile

Figure 2 - Example of dust and other material on horizontal surfaces

7. High performance dusting in most spaces should occur regularly, to include window sills, ledges and hidden spaces *typically out of reach*
 - a. Special attention should be directed towards horizontal surfaces on doors, furnishings, baseboards, and switch covers.

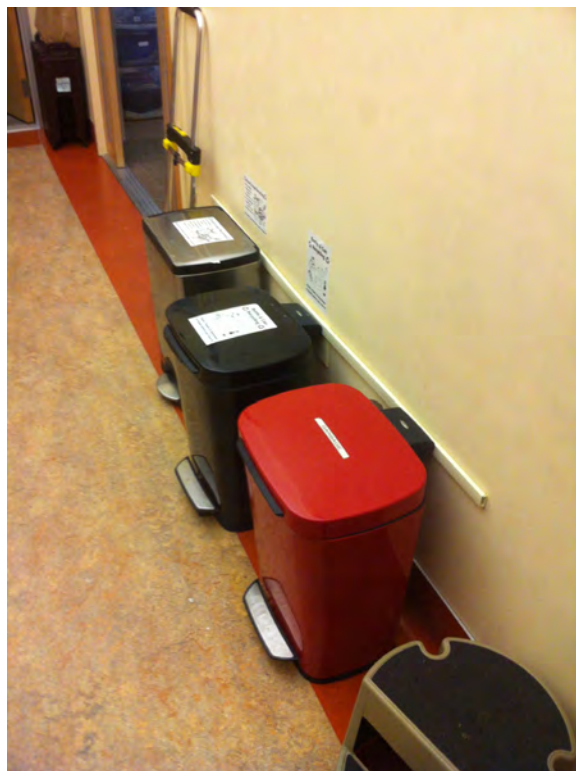
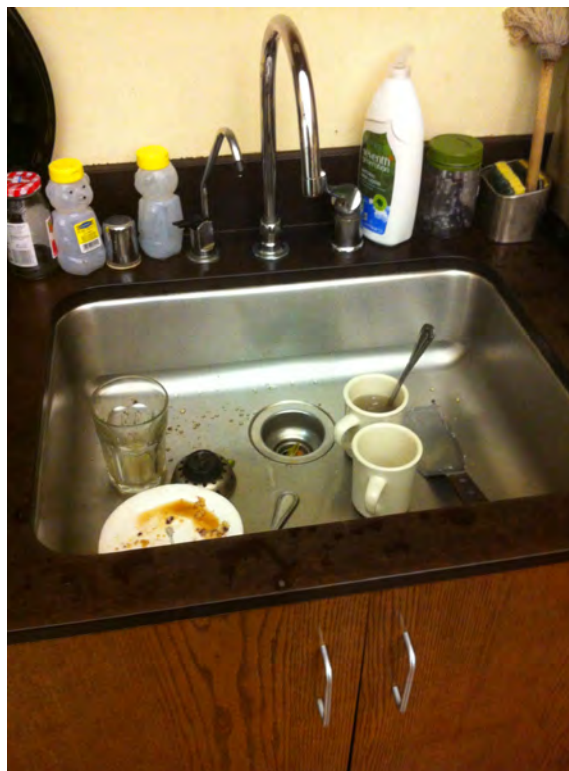
9. Scuffs were evident on common area walls and doors; along with light paint chipping on wall edges
10. Several areas, most notably kitchen areas, had overflowing waste receptacles along with light food debris on countertops.

Figure 3 - Examples of kitchen area counter top and waste receptacles

8. Horizontal surfaces in break areas should be wiped down regularly and special attention should be paid to corners and under appliances such as the coffee machine, microwave, and refrigerator.

- a. Additionally clutter on counter tops may make it difficult for custodial services to appear effective, supplies should be stored properly when not in use.

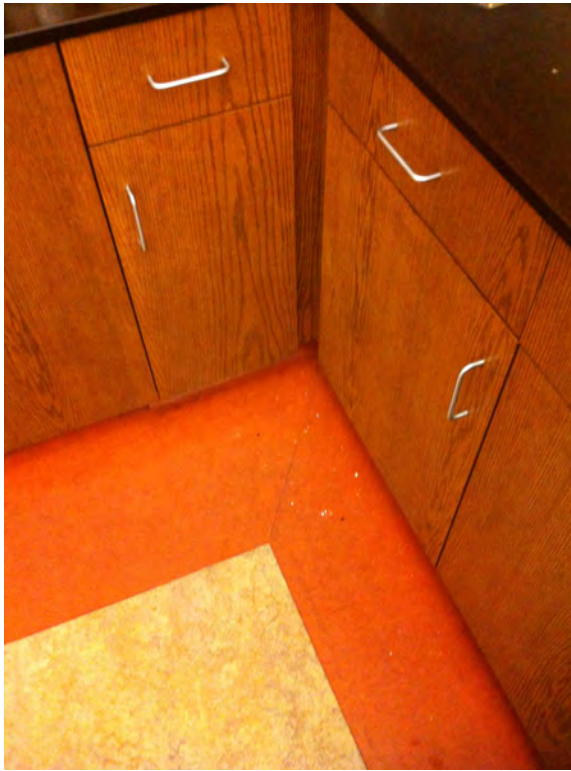
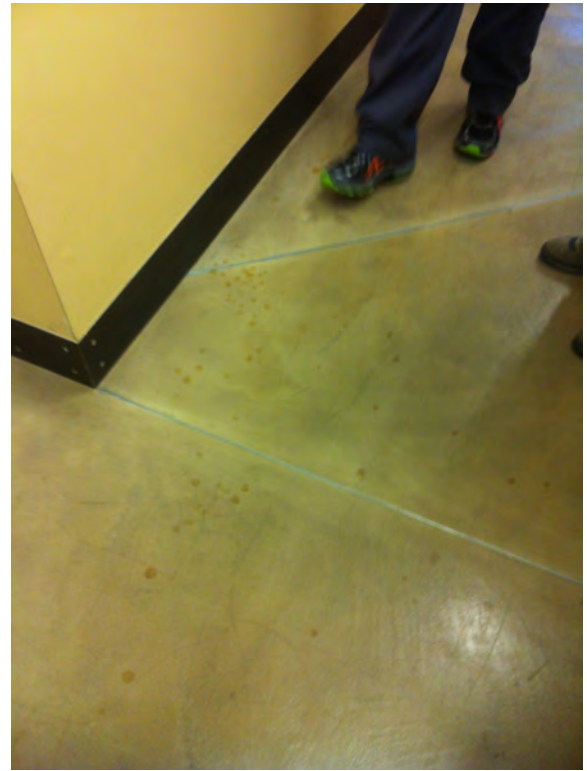
3. Hard surface floors inside the building were very well kept
4. Resilient flooring in the kitchen area was the only space with indications of markings on the surface

Figure 4 - Example of material on resilient flooring

2. Resilient flooring is relatively new, installed during the LEED NC project. Flooring should be protected whenever possible to elongate its life.
 - a. Mats are recommended in area entryways such as the door to the break room.

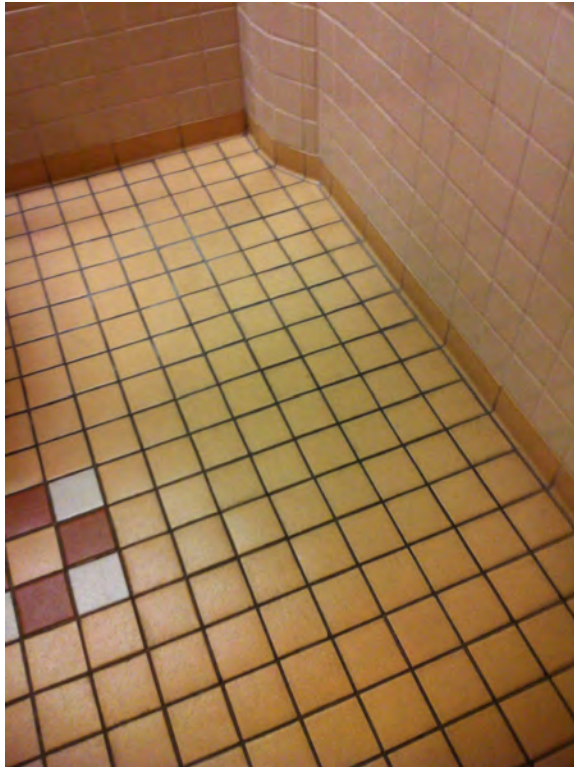
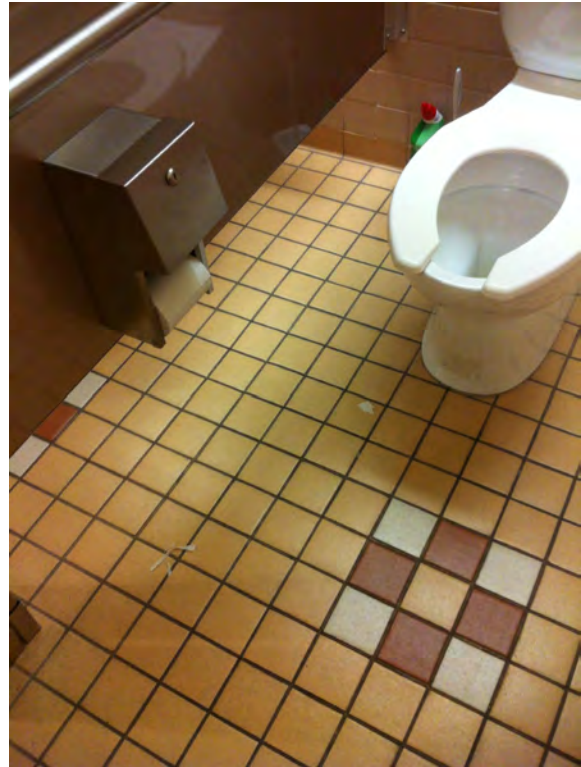
Figure 5 - Example of tile in restrooms and spills on hard floor

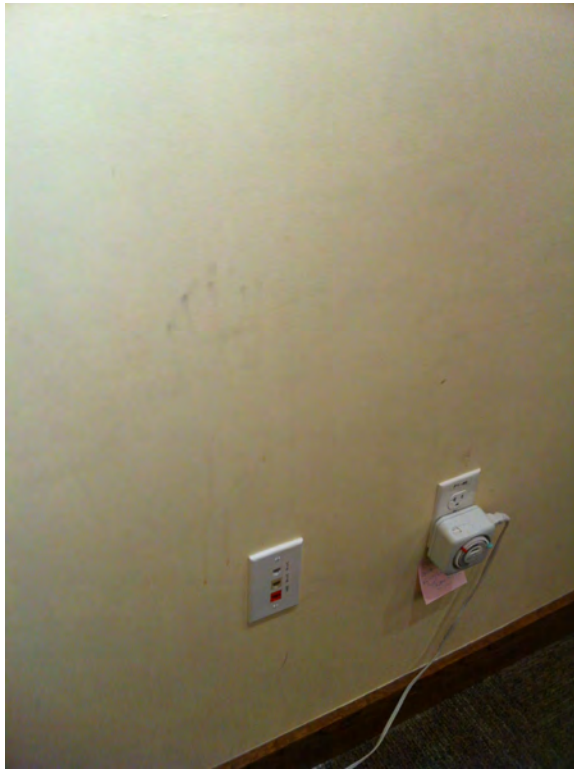
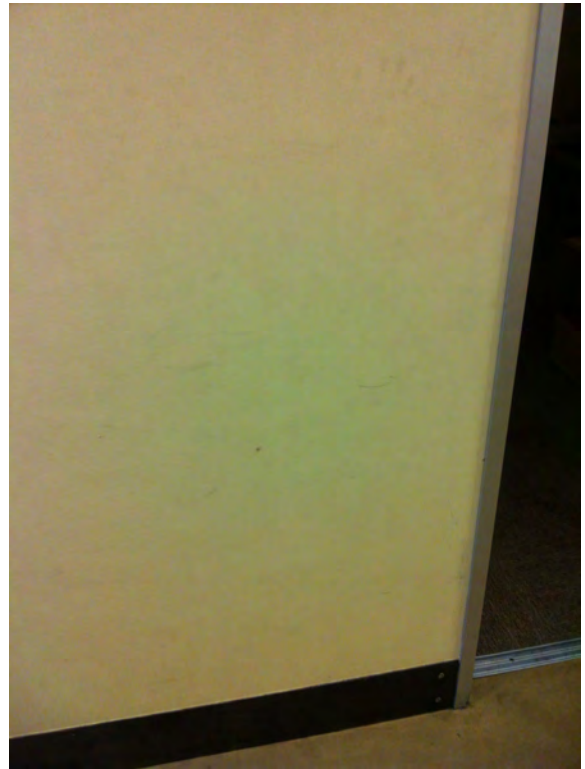
Figure 6 - Example of markings on vertical surfaces

6. Common area walls and doors should be wiped clean paying special attention to markings and damage. Spot painting should be implemented occasionally to reduce the apparent accumulation of marks and damage on walls when cleaning is no longer sufficient.

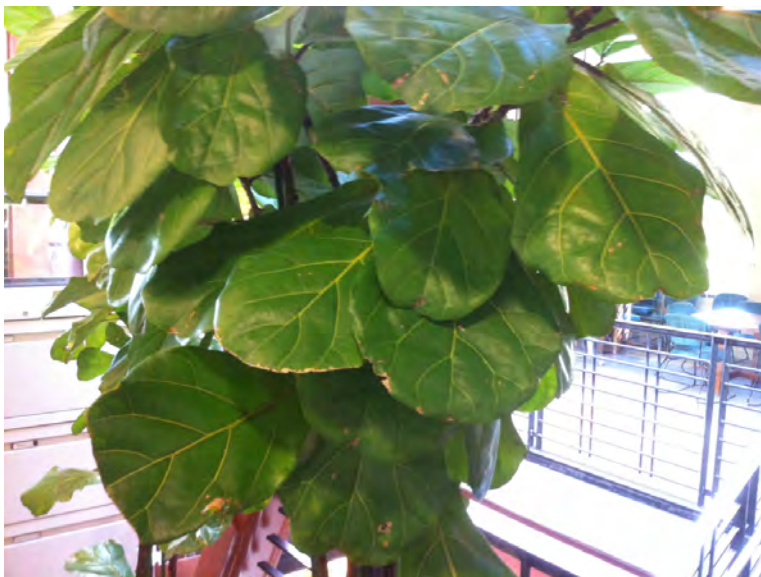
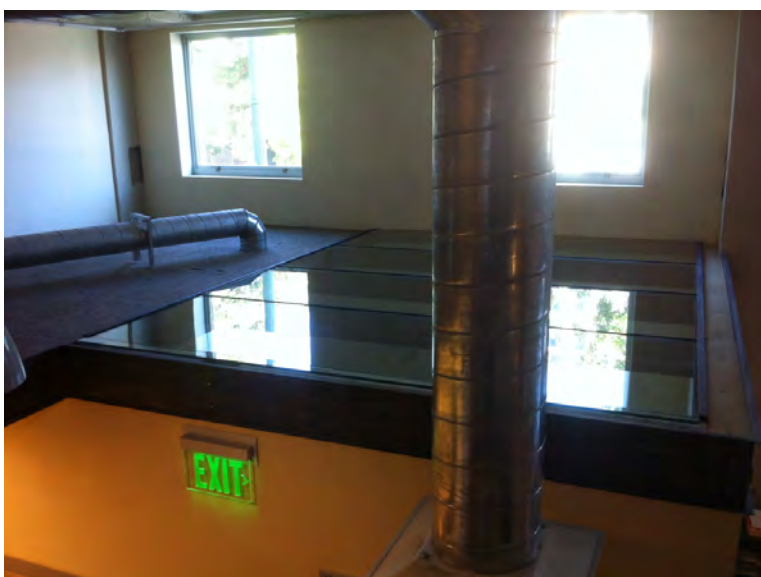
Figure 7 - Examples of Exemplary Cleanliness

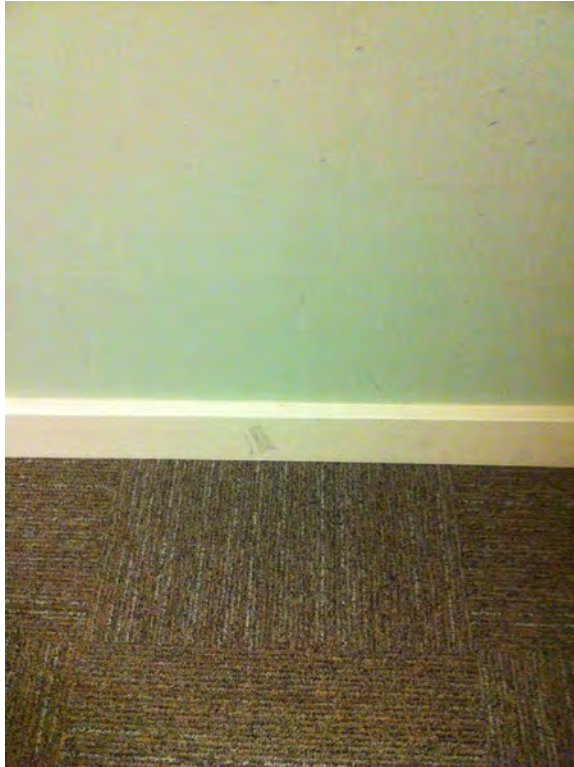
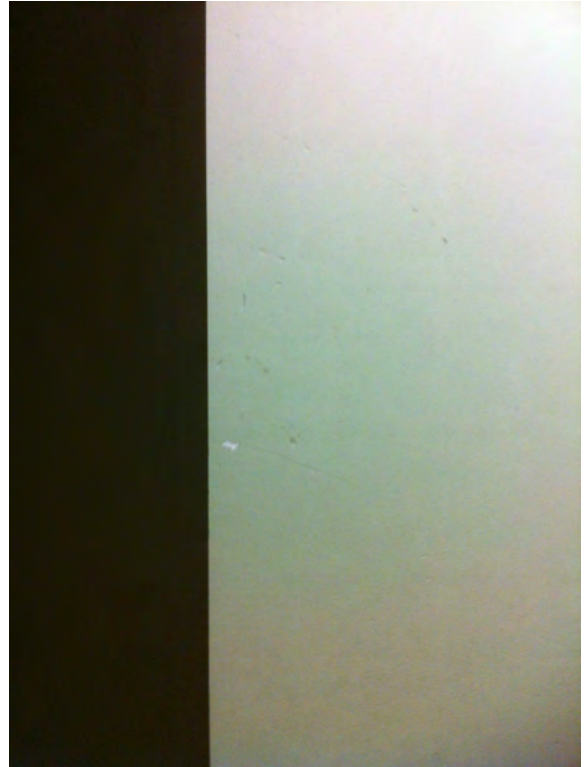
Figure 8 - Examples of markings on walls

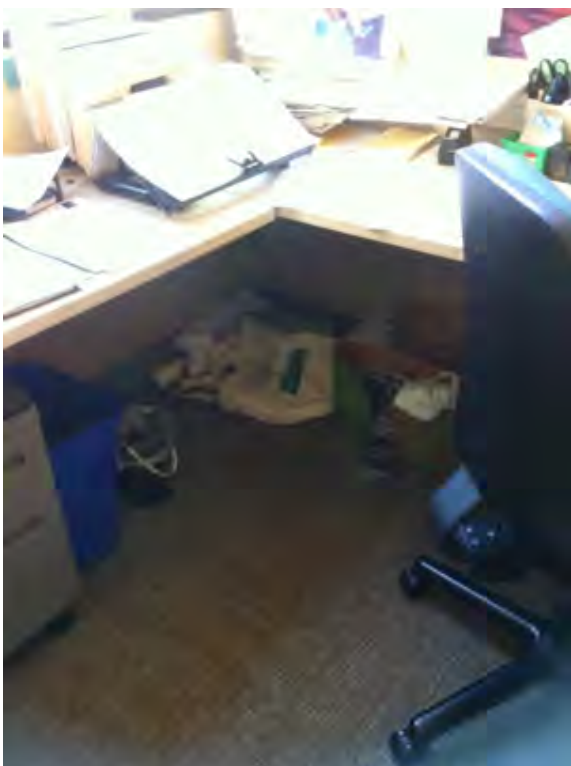
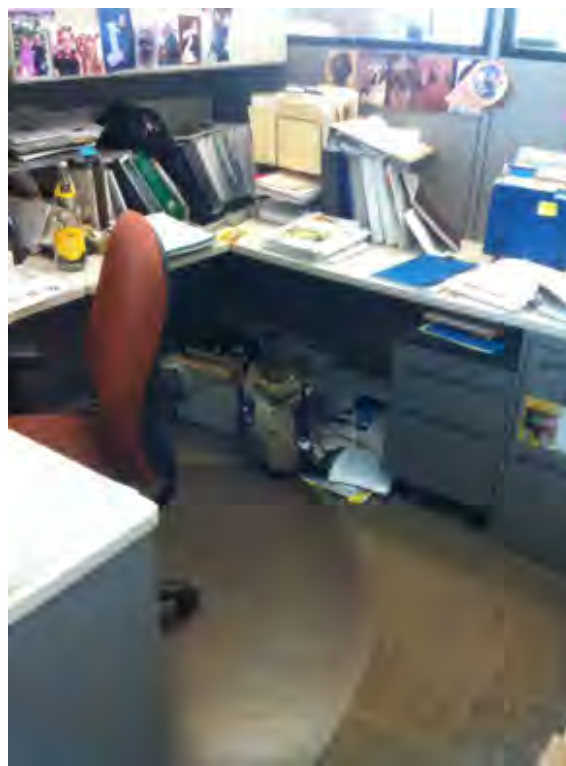
1. The building was found to be clean and well kept. Upon superficial inspection, the custodial services appear to be very effective
2. Clutter in office cubicles may hinder the effectiveness of custodial services

Figure 9 - Examples of clutter under desks in cubicle areas

1. Instruct occupants to reduce clutter wherever possible so that custodial services are optimally effective.

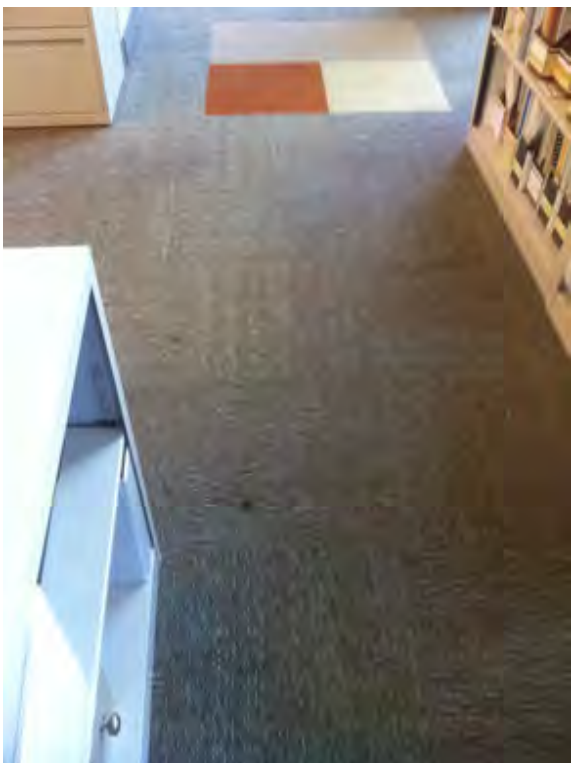
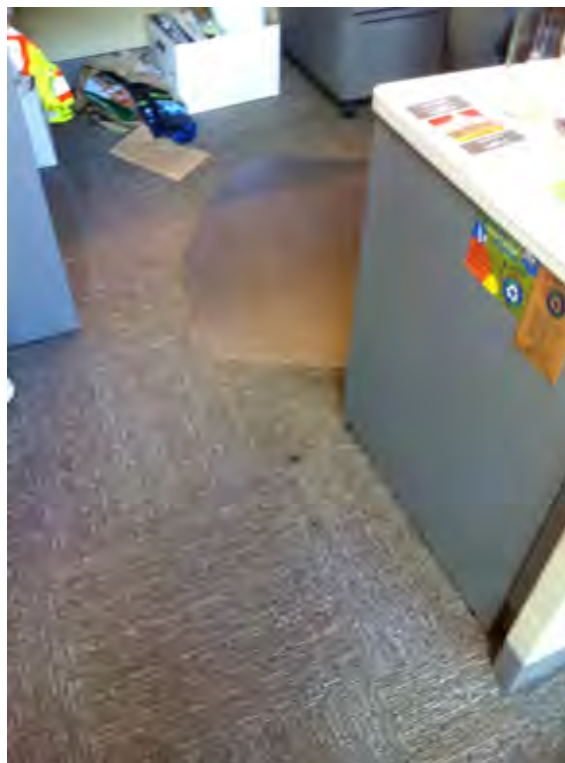
6. Light fixtures were found to be clean
7. Glass partitions were found to be clean and free of smudges
8. Carpet in high traffic areas had small spots and stains

Figure 10 - Examples of staining on carpets

4. Light fixtures should be dusted bi-annually to prevent dust build up.
5. Deep cleaning of carpets in high traffic areas more frequently, and spot cleaning of carpets in high traffic areas and cubicles frequently
