ASHRAE LEVEL II ENERGY AUDIT

STOPWASTE.ORG

PROJECT NUMBER 0313.020

November 8, 2013

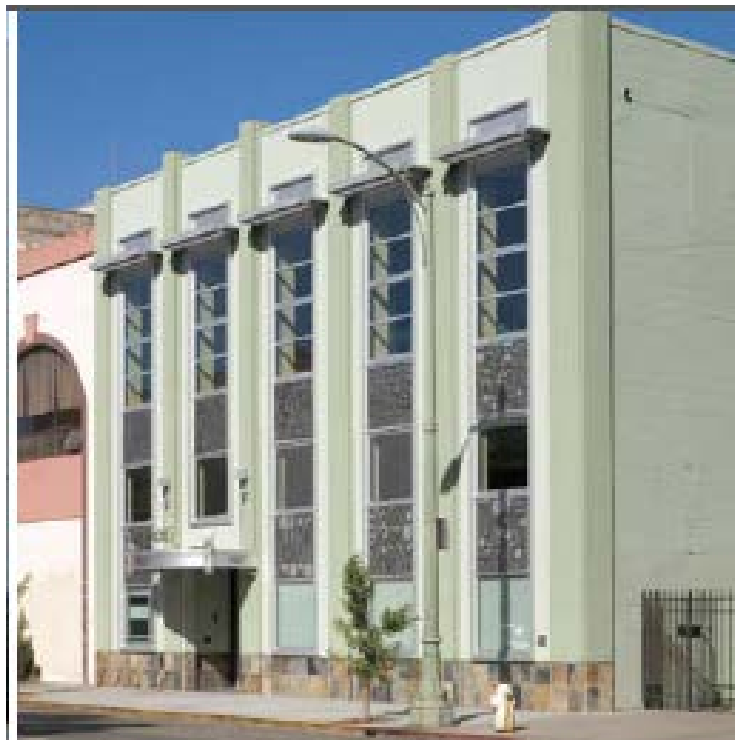
Figure 2-1: East Elevation

The original construction for 1537 Webster Street occurred in 1926 as a 2-story building. The building underwent renovations in 2007. The building is a concrete structure with an open floor plan. A cool roof and a 5.2-kilowatt photovoltaic system have been installed on the roof. Flooring consists of stained concrete on the ground floor and carpeting in the boardroom and on the second floor. The north, west, and east façades feature large dual paned operable windows on both the first and second floor. There are no windows on the south façade. Figure 2-1 shows a picture of the east elevation of the building.

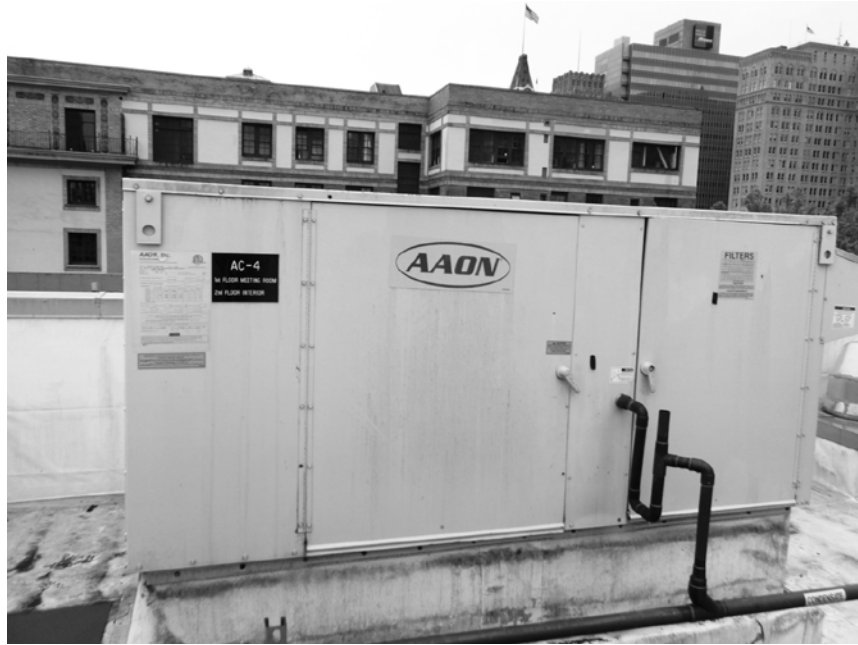
Figure 2-2: Typical Roof Top Packaged AC Unit

The cooling system for the building consists of four roof top packaged AC units; three systems feature a gas heating mode and variable frequency drives. All four roof top units feature an outside air (OA) economizer with flow measuring stations to provide free cooling and ventilation. The OA dampers on two units (AC units 1&3) have been locked open at 100%; this may be due to faulty flow stations. The flow stations will override any command based on the measured airflow and will continue to open the OA dampers until the OA minimum setpoint has been satisfied. AC 4 economizer is 100% closed; this is due to humidity control in the IT room. AC 2 economizer appears to be fully functional. These HVAC systems provide temperature control and ventilation for the building; see Table 2.1 below. Figure 2-2 shows a typical packaged AC unit with OA economizer. There are two exhaust fans located on the roof, EF-1 for general exhaust and EF-2 that serves the elevator room with thermostatic temperature control. A third exhaust fan that serves the shower room is interlocked with the light switch.

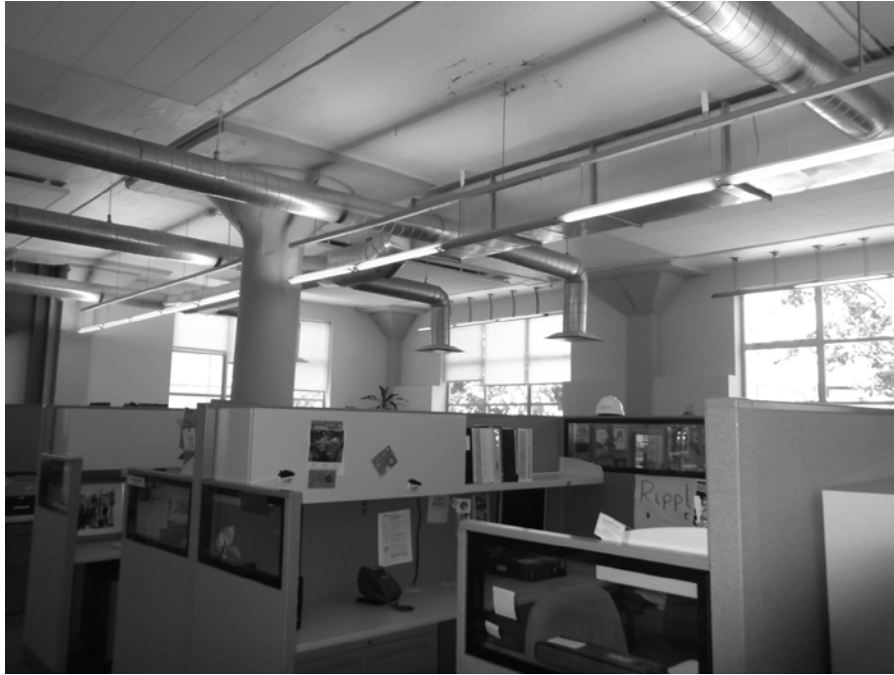
Figure 2-3: Second Floor Open Office space

The lighting control system controls interior, exterior, and exhaust fan on/off schedules. The lighting throughout the building area is composed of multiple types of fluorescent lamps. There is one skylight that provides natural lighting to the main stairwell and entry area. The primary space lighting on the first floor are 36 and 42 watt CFL's. The primary lighting for the second floor open office space and private offices is primarily composed of 4-foot fluorescent luminaries' lit with 28-watt T5 lamps; see Figure 2-3.

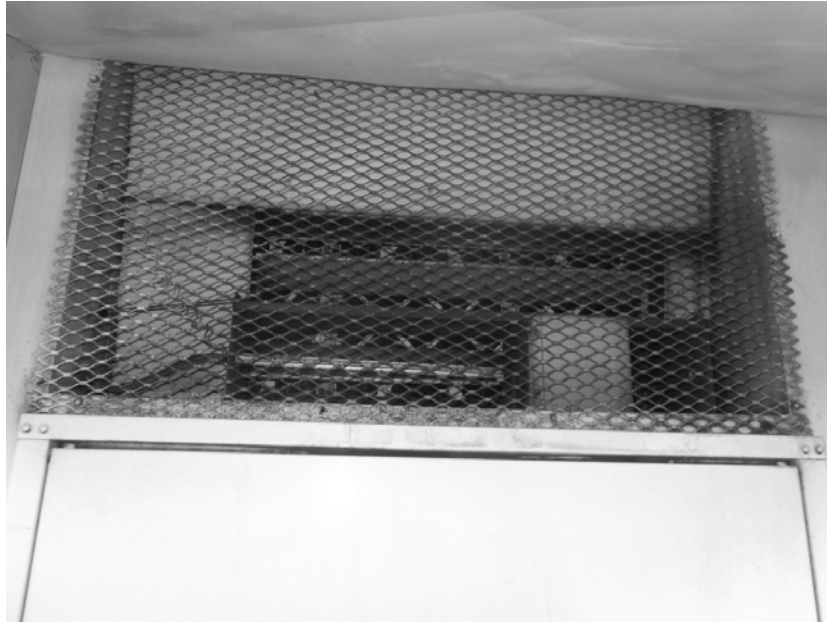
Figure 4-2: AC 1 outdoor air damper

The outdoor airflow stations monitor outdoor air flow to the spaces served and override any commands based on the amount of minimum outdoor air needed for proper space ventilation. The air flow stations on AC units 1&3 are not working properly and are forcing the outdoor air dampers to stay at 100% open. AC 4 economizer is 100% closed; this is due to humidity control issues in room 204.

Reconfigure economizer control:

1. Check outdoor air sampling tube operation (Clean and measure delta P)
2. Install filters upstream of the airflow sampling tubes.
3. Disconnect stand alone outdoor air damper override control.
4. Reprogram BAS economizer control to include outdoor airflow readings (utilizing existing differential pressure transducer) and control outdoor air dampers based on outdoor airflow readings.
5. Have BAS generate an alarm through occupant computer network: if minimum outdoor airflow readings are over/under expected outdoor airflows based on outdoor air temperatures and economizer mode for more than 1 hour.
6. If alarm is generated open outdoor air damper to 100% outdoor airflow, check outdoor air sampling tube, differential pressure transducer and damper operation.

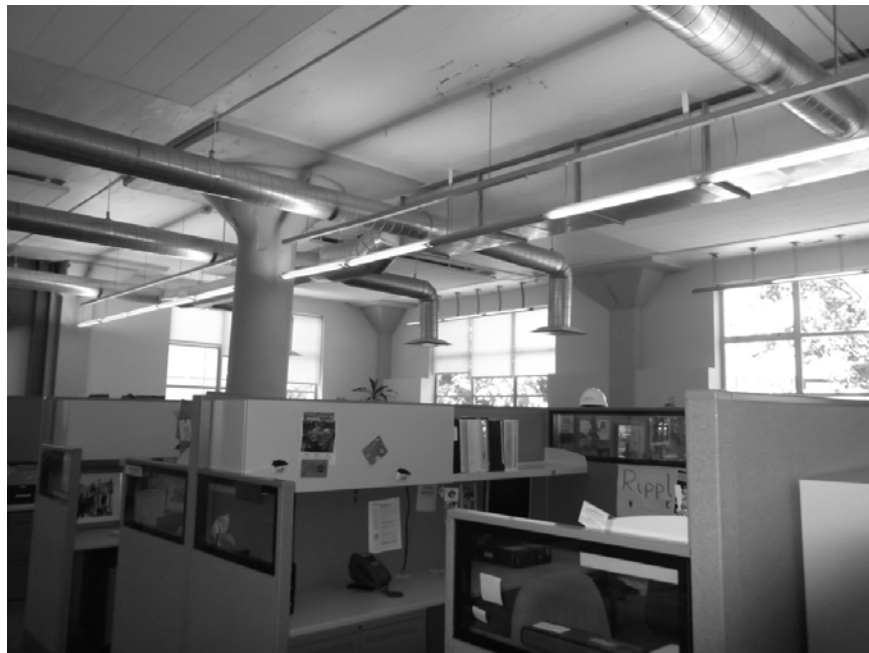
Figure 4-3: Open office lighting

Currently all the lighting at the StopWaste.org office is connected to occupancy sensors, however in the open office areas, multiple lights are connected to a single sensor. In order for the lights in a given area to turn off, none of the cubicles in that area can be occupied.

It is recommended that the existing lights be lowered and individual occupancy sensors be installed so that each work space is on a separate circuit. By separating the lighting occupancy controls, when a

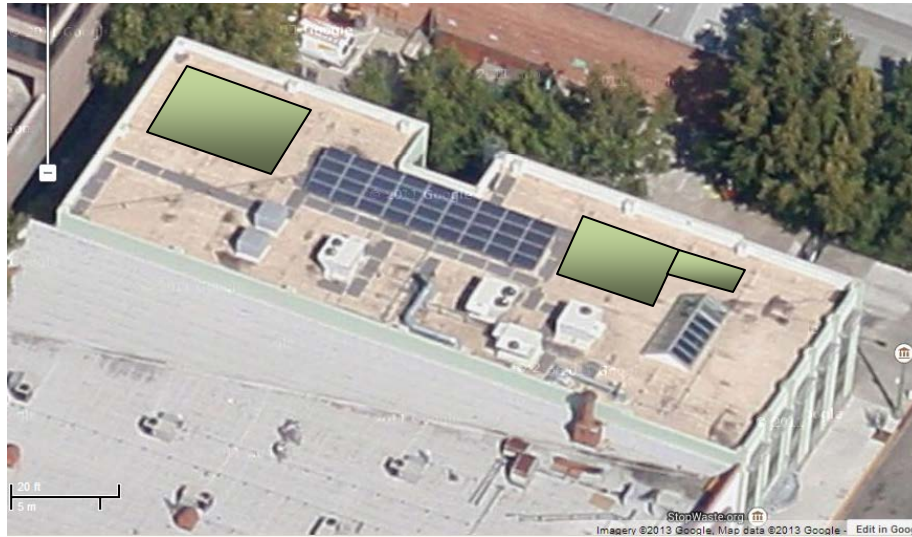
Figure 4-4: Solar Array at the StopWaste.org building

Currently there is a 5.2 kW solar PV array on the roof of the StopWaste.org building sized to meet 10% of the building electrical load. There is additional space on the roof that is unused. By increasing the size of the solar PV array, StopWaste.org can further reduce the building electrical energy consumption. A reduction in peak demand and annual energy consumption can be expected, as well as a reduced need to purchase renewable power certificates to maintain carbon neutral standing.

There is enough unused roof space to install 7.7 kW of additional PV panels on the StopWaste building if the same panel type is used. The proposed additional array will not restrict access to other roof top systems. Figure 4-4 shows potential space for additional solar PV indicated by the green boxes. The additional solar PV panels will provide for 30% of the building peak demand, and reduce annual energy use by 15%. When the existing system is included, total reduction in demand due to solar PV will be greater than 50% and total reduction in energy about 25%.

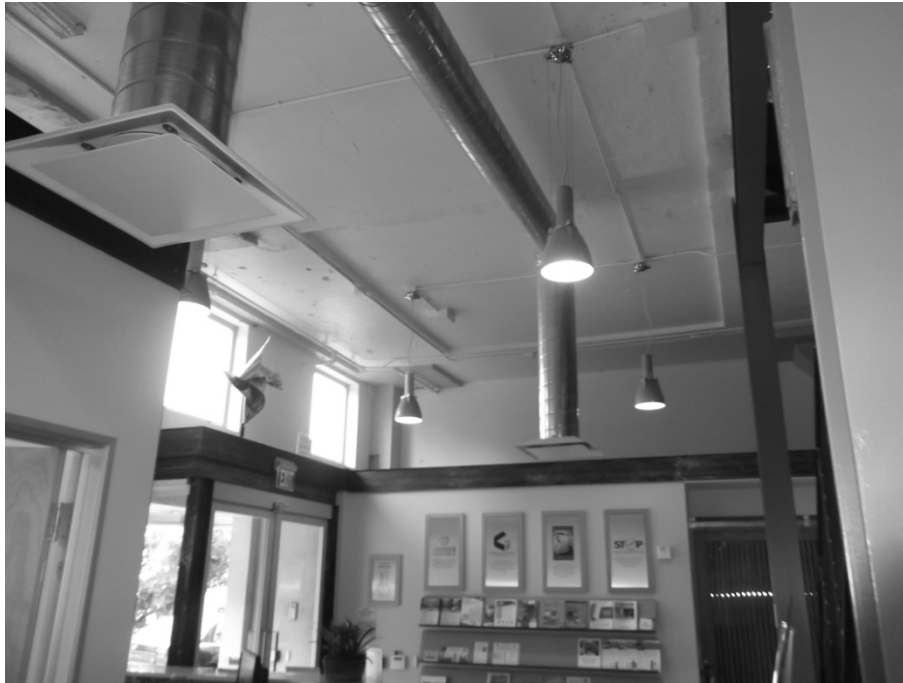
Figure 4-5: Therma Fuser™

The buildings' air distribution is a Therma Fuser™ type variable flow diffuser. Therma Fuser™ boxes use thermal wax in a cylinder that expands and contracts as the wax heats or cools. The expansion / contraction of the wax opens or closes the damper in the box to maintain air flow and thermostat set points. Thermostats are located at the diffuser. From discussion with building occupants, these boxes regularly become un-calibrated, and deliver too much or too little air to maintain space comfort.

This measure involves regular balancing of the Therma Fuser™ registers to ensure proper calibration and space comfort. Annual balancing is recommended, however more frequent balancing may be required.
