*ASHRAE LEVEL I ENERGY AUDIT*

# STOPWASTE.ORG

**PROJECT NUMBER 0313.020**

***November 8, 2013***

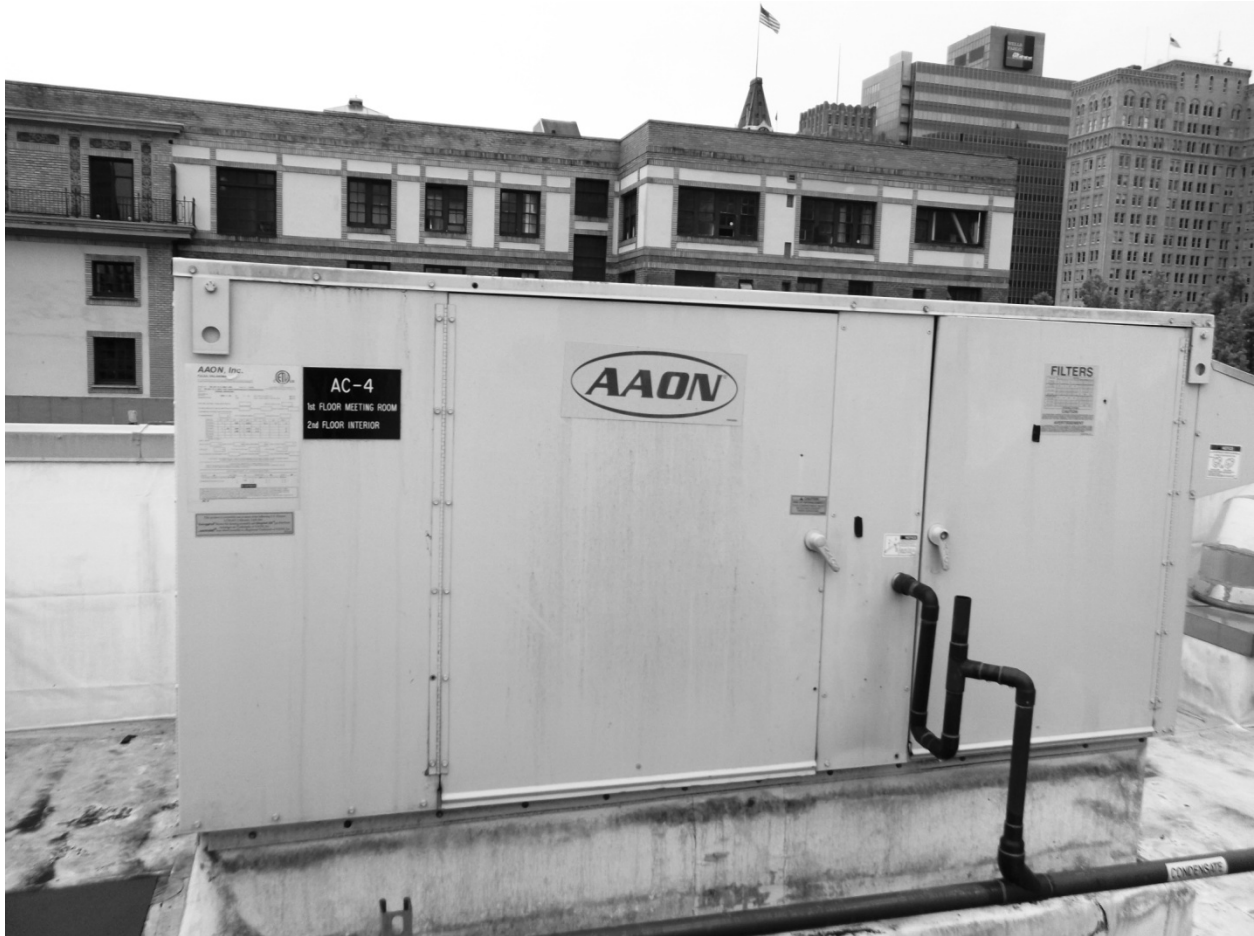
**Figure 2.2: Typical Roof Top Packaged AC Unit**

The cooling system for the building consists of four roof top packaged AC units; three systems feature a gas heating mode and variable frequency drives. All four roof top units feature an outside air (OA) economizer with flow measuring stations to provide free cooling and ventilation. The OA dampers on two units (AC units 1&3) have been locked open at 100%; this may be due to faulty flow stations. The flow stations will override any command based on the measured airflow and will continue to open the OA dampers until the OA minimum setpoint has been satisfied. AC 4 economizer is 100% closed; this is due to humidity control in the IT room. AC 2 economizer appears to be fully functional. These HVAC systems provide temperature control and ventilation for the building; see Table 2.1 below. Figure 2.2 shows a typical packaged AC unit with OA economizer. There are two exhaust fans located on the roof, EF-1 for general exhaust and EF-2 that serves the elevator room with thermostatic temperature control. A third exhaust fan that serves the shower room is interlocked with the light switch.

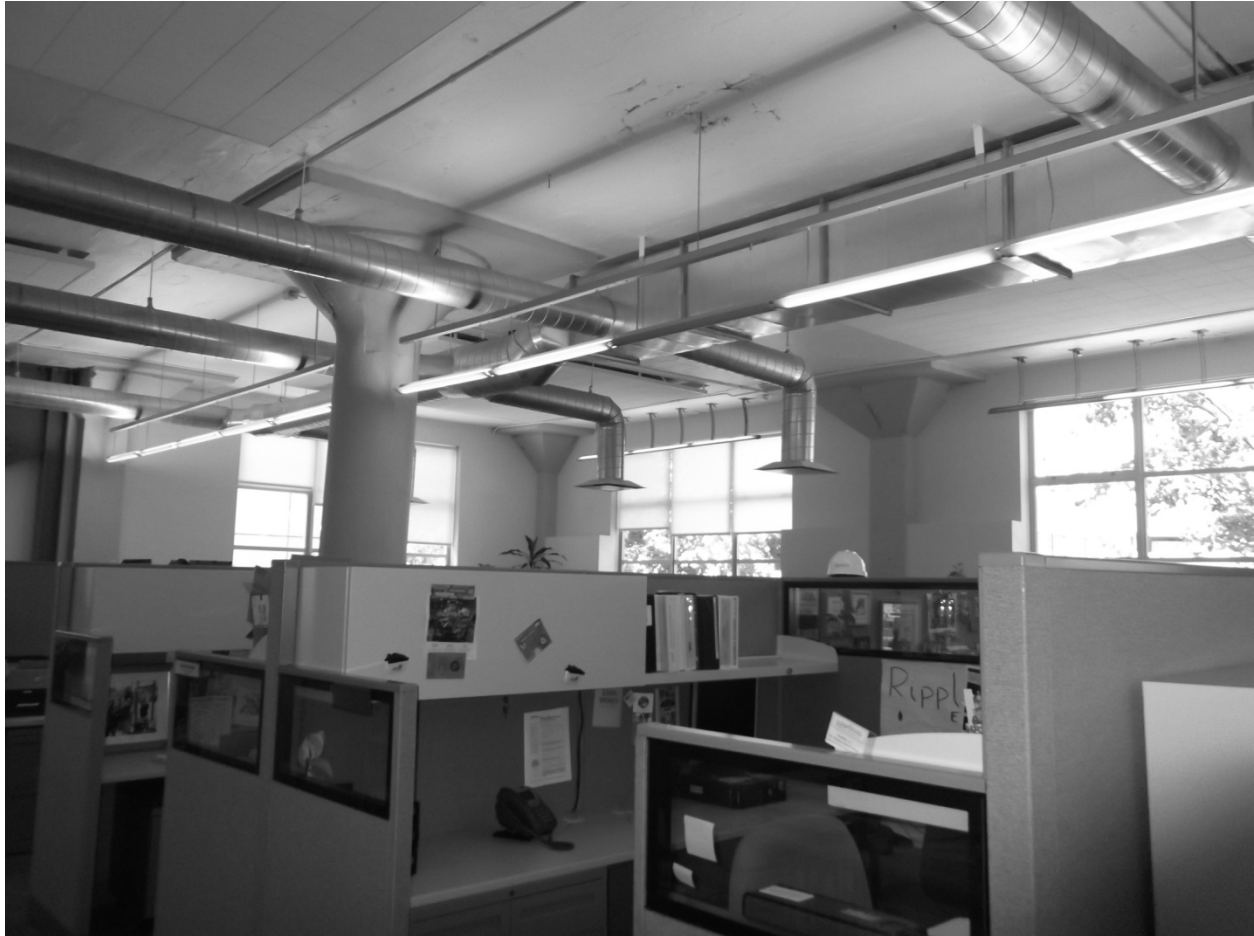
**Figure 2.3: Second Floor Open Office space**

The lighting control system controls interior, exterior, and exhaust fan on/off schedules. The lighting throughout the building area is composed of multiple types of fluorescent lamps. There is one skylight that provides natural lighting to the main stairwell and entry area. The primary space lighting on the first floor are 36 and 42 watt CFL's. The primary lighting for the second floor open office space and private offices is primarily composed of 4-foot fluorescent luminaries' lit with 28-watt T5 lamps; see Figure 2.3.

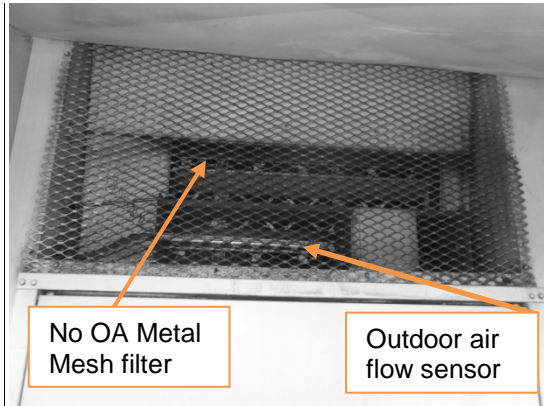
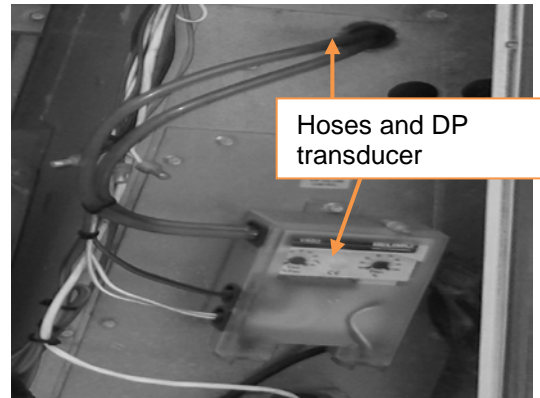
**Figure 2.5: Typical Site AC unit Operational Issues**

All major mechanical equipment inspected is in good working condition with the exception of the outdoor air flow stations on AC's 1 and 3. The outdoor airflow stations monitor outdoor air flow to the spaces served and override any commands based on the amount of minimum outdoor air needed for proper space ventilation. The air flow stations on AC units 1&3 are not working properly and are forcing the outdoor air dampers to 100% open. Possible causes may be:

1. Clogged air flow sensors: there are no filters upstream of the sensors to help keep them from clogging up.
2. Faulty differential pressure transducers
3. Improper transducer settings
4. Cracked and/or loose hoses

See photo's below

Reconfigure economizer control:

1. Check outdoor air sampling tube operation (Clean and measure delta P)
2. Install filters upstream of the airflow sampling tubes.
3. Disconnect stand alone outdoor air damper override control.
4. Reprogram BAS economizer control to include outdoor airflow readings (utilizing existing differential pressure transducer) and control outdoor air dampers based on outdoor airflow readings.
5. Have BAS generate an alarm through occupant computer network: if minimum outdoor airflow readings are over/under expected outdoor airflows based on outdoor air temperatures and economizer mode for more than 1 hour.
6. If alarm is generated open outdoor air damper to 100% outdoor airflow, check outdoor air sampling tube, differential pressure transducer and damper operation.

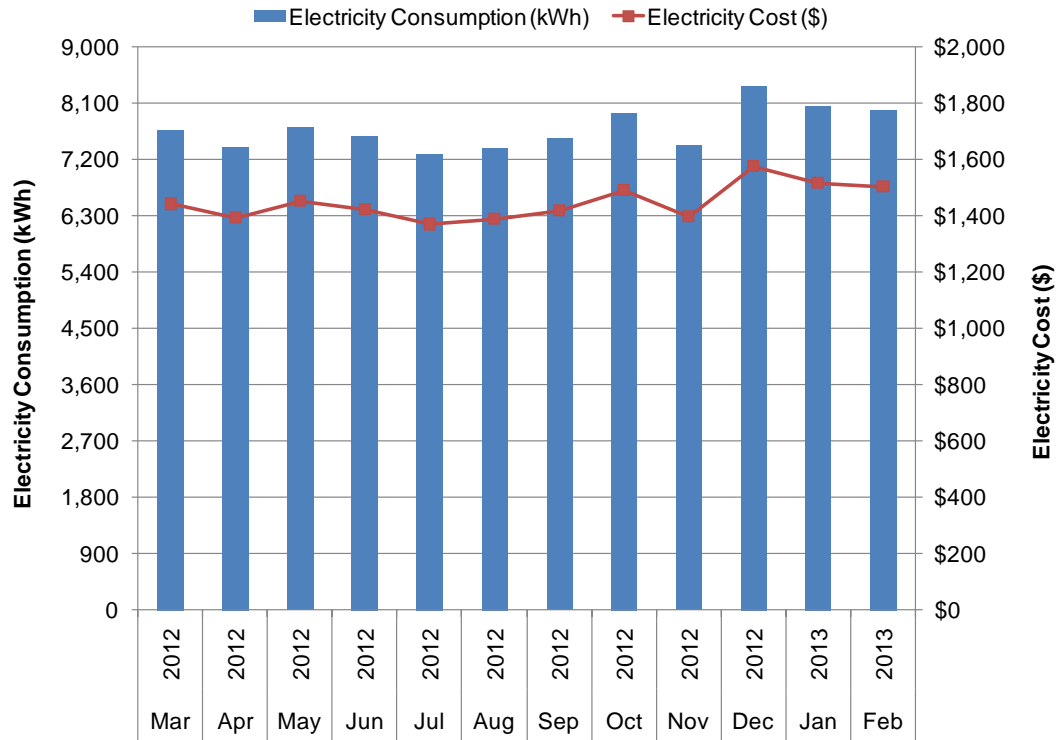
**Table 3.2: Monthly Electricity Cost and Consumption**

This section provides a summary of the building's electrical energy consumption. Electricity is supplied by PG&E; natural gas service from PG&E has been disconnected. The monthly electrical usage and costs for March 2012 through February 2013 were acquired from the building's Energy Star portfolio manager account. Table 3.1 provides a summary of the annual utility consumption and costs based on PG&E utility bills from March 2012 through February 2013. The annual electrical energy usage intensity and cost usage intensity is 6.3 kilowatt-hour (kWh) per square foot (ft<sup>2</sup>) and \$1.18 per square foot, respectively. The average electric cost is \$0.188 per kWh. Table 3.2 shows the monthly electricity usage and costs.

No major monthly irregularities have been noted. The monthly usage for the most part consistently stays between 7200 and 7600 kWh with the exception of December through February. Possible causes:

1. End of the year board room holiday parties and meetings
2. Beginning of the year board room meetings, training, and new developments.

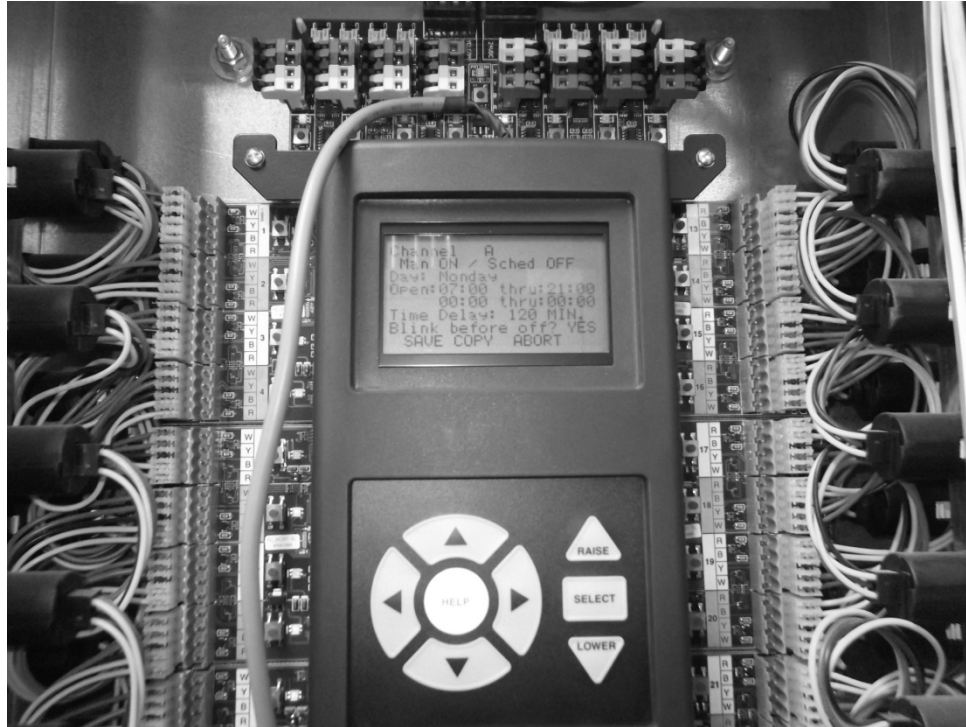
**Figure 4.1: Interior lighting schedule**

The building is typically occupied from 7:30am to 5:30pm Monday through Friday and interior lighting operates from 7am to 9pm Mondays through Friday.

##### Proposed Schedule:

7am to 7pm Monday through Friday

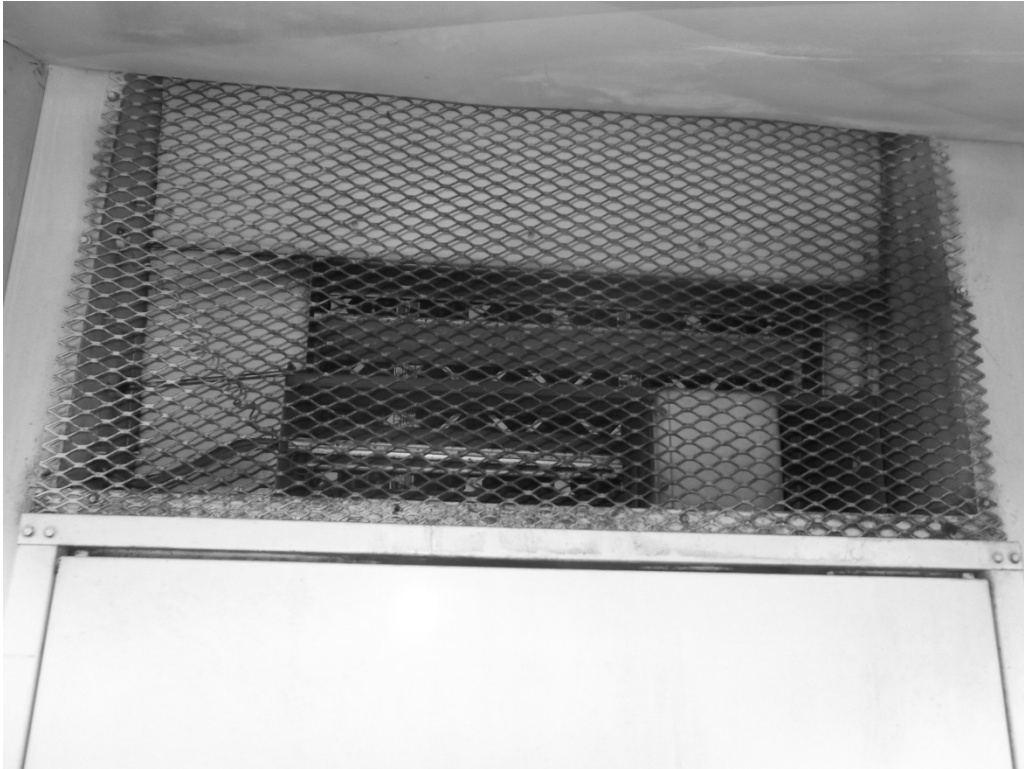
**Figure 4.2: AC 1 outdoor air damper**

The outdoor airflow stations monitor outdoor air flow to the spaces served and override any commands based on the amount of minimum outdoor air needed for proper space ventilation. The air flow stations on AC units 1&3 are not working properly and are forcing the outdoor air dampers to stay at 100% open. AC 4 economizer is 100% closed; this is due to humidity control issues in room 204.
