# Regal® Flushometer

NOTE: Also for use with Regal® XL  
(Since mid-2010)

The repair kits and parts listed on this page are designed to service all Sloan diaphragm type flushometers, including those manufactured for low consumption (LC) usage.

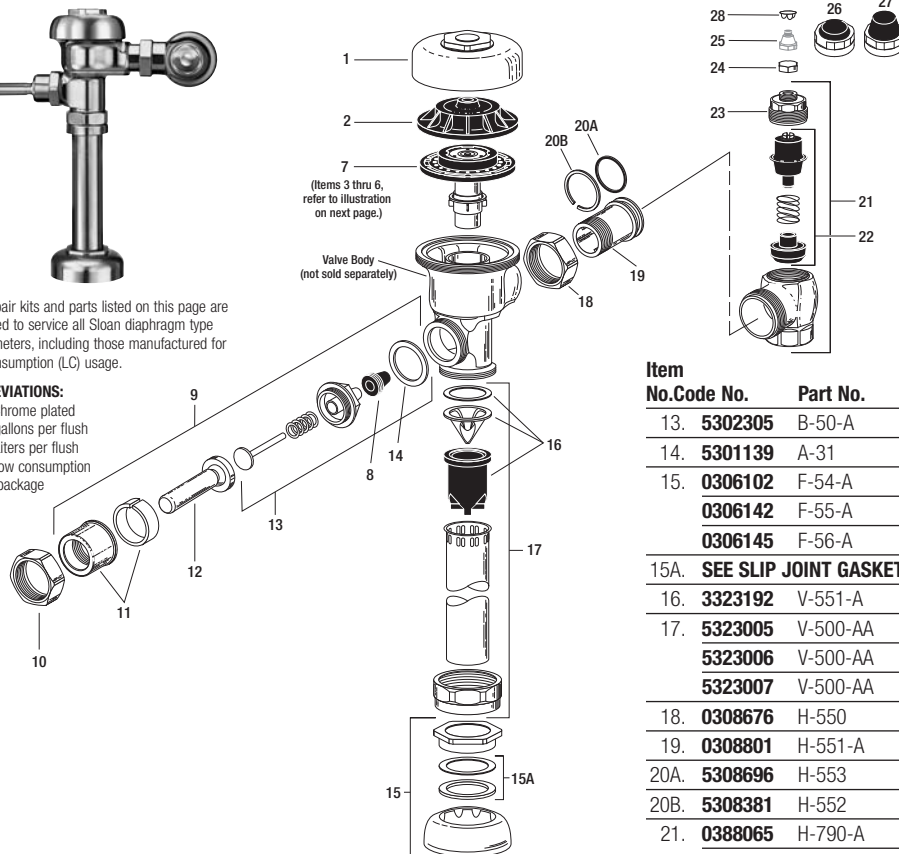
## PARTS LIST

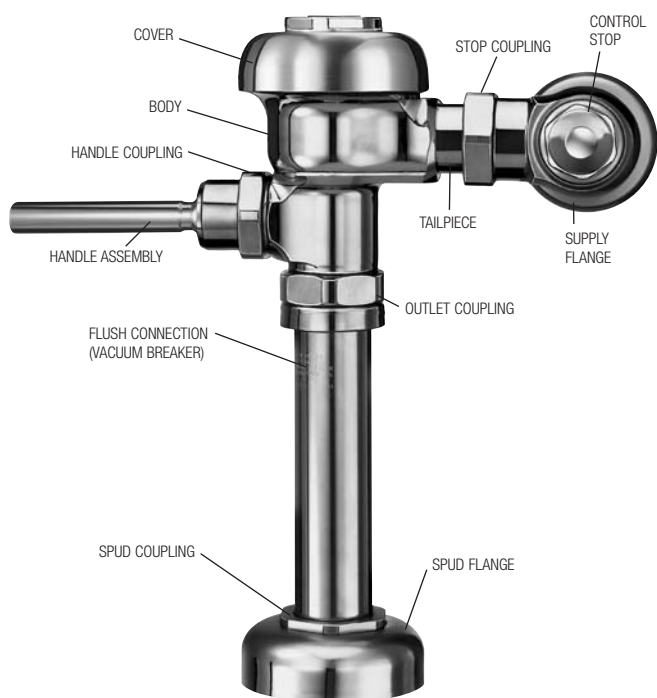
### MASTER FLUSHOMETER REBUILDING KITS (SEE PARTS LIST – ON PREVIOUS PAGE)

Refer to Parts List. Includes Items 7, 13, 16 & 20

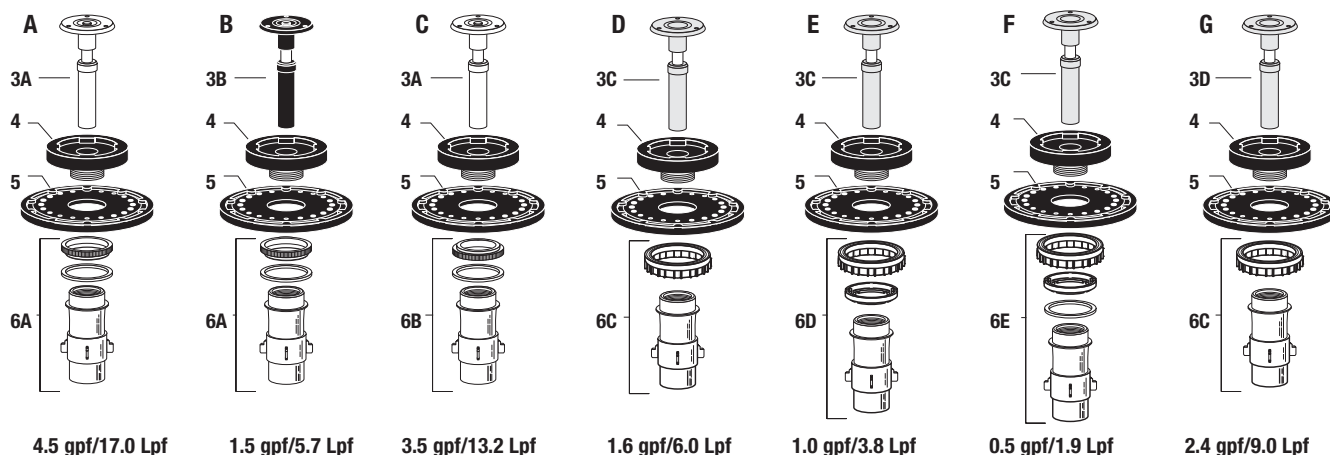
### ITEM 7. INSIDE PARTS KITS (SEE ILLUSTRATIONS BELOW)

### ITEM 7. INSIDE PARTS COMPONENTS (SEE ILLUSTRATIONS BELOW)
